Contract #: 04-0120F4Cty: SF/ALA Rte: 80 PM: 13.2/13.9File #: 69.28**WELDING INSPECTION REPORT****Resident Engineer:** Pursell, Gary**Address:** 333 Burma Road**City:** Oakland, CA 94607**Report No:** WIR-001892**Date Inspected:** 01-Apr-2008**Project Name:** SAS Superstructure**OSM Arrival Time:** 630**Prime Contractor:** American Bridge/Fluor Enterprises, a JV**OSM Departure Time:** 1730**Contractor:** Zhenhua Port Machinery Company, Ltd (ZPMC), Changxing Island **Location:** Shanghai, China**CWI Name:** Chen Xie**CWI Present:** Yes No**Inspected CWI report:** Yes No N/A**Rod Oven in Use:** Yes No N/A**Electrode to specification:** Yes No N/A**Weld Procedures Followed:** Yes No N/A**Qualified Welders:** Yes No N/A**Verified Joint Fit-up:** Yes No N/A**Approved Drawings:** Yes No N/A**Approved WPS:** Yes No N/A**Delayed / Cancelled:** Yes No N/A**Bridge No:** 34-0006**Component:** OBG deck panels**Summary of Items Observed:**

OBG bay 1 (Gantry 2)

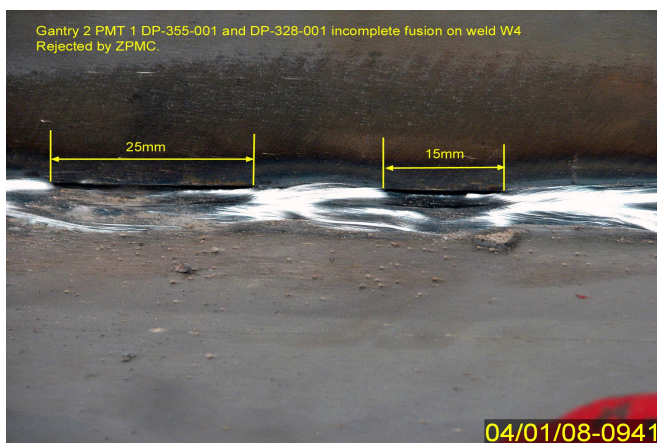
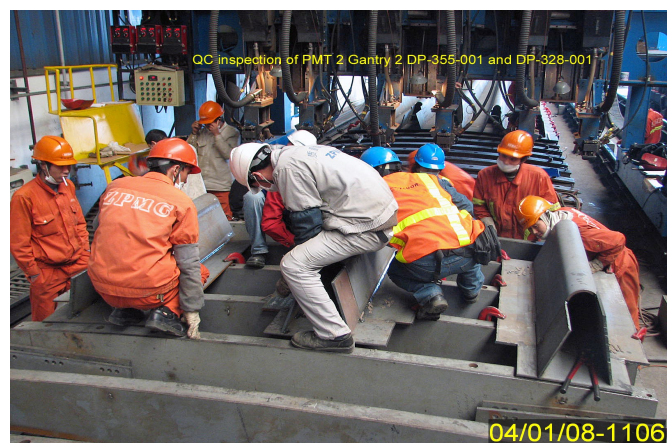
After the completion of PMT 2 QA observed ZPMC qualified welding personnel perform the GMAW welds joining the closed U-Ribs to deck panel DP-355-001. QA observed 4 ZPMC QC inspectors in the vicinity of the welding operations including ZPMC CWI identified as Chen Xie. There were also 4 American Bridge/Fluor (ABF) inspectors in the area as well. QA and ABF QC inspectors performed a random visual inspection of the GMAW root welds on this panel. ZPMC was not observed performing VT on the root welds. All welds appeared to meet the requirements of the contract documents. QA and QC monitored the welding process continuously throughout the day. QA's shift ended before ZPMC performed the SAW welds on the above mentioned panel. QA partially completed a production panel welding report for the above mentioned panel. The report is on file in the Caltrans QA office. The welding parameters as measured with the calibrated gages on the machines appeared to be in conformance with the posted WPS's and are as follows:

GMAW

Volts: 30.1 – 30.9 Amps: 367 – 381 Travel Speed: 540 mmpm
